6.1 j Cassowary Fence Trial 2010 Ella Bay

Report on
Cassowary Exclusion Fence Trials
At
Ella Bay

July 2011 Revision 2

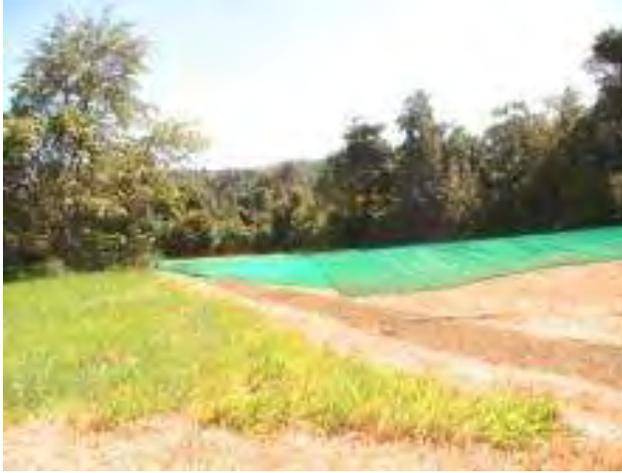
The shade cloth fence (170g/m²) was lifted 1.5m off the ground at the centre of the span before the high tensile 2.8mm 8kN wire failed (the wire is rated at a minimum breaking strain of 8kN). The test was repeated two (2) times with similar results. The shade cloth fence only sagged 0.3m over 150m. In practice the top wire would be tensioned to 50% of the breaking strain with mid-span posts. If the shear clips fail and release the fence the additional mass of unsupported fence would not be exceeded only the sag would be greater. The theoretical sag for tensioning to 50% for 150m would be 1.1m of sag. That is if all the clips were released in a length of fence 150m long the fence would be 0.9m high in the centre. When the shade cloth starts to lift there is very little tension, but there is significant increase in force as the shade cloth mass is lifted due to the wire supporting the mass of the shade cloth which is progressively lifted from the ground with increase in tension.

Figure 4.10 Fence sag test – no posts

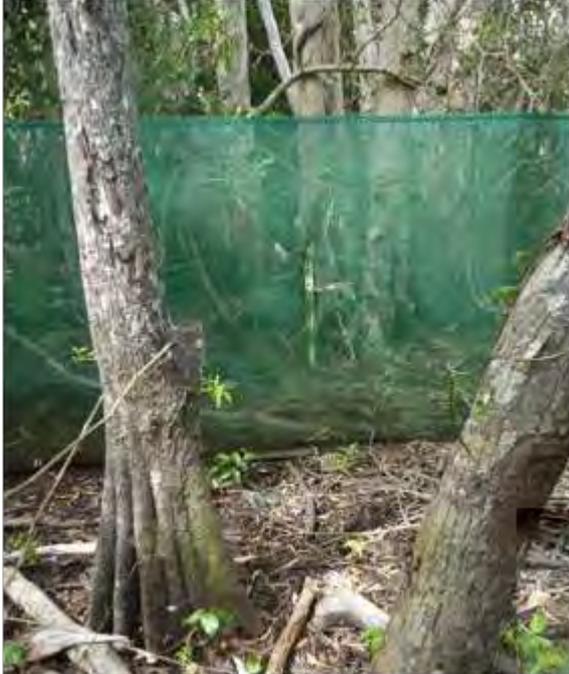
The fence within the vegetation suffered no damage over the 2009/10 wet season with a number of small branches falling on the fence; not sufficient to release the shear clips and one section of fence partially flooded without damage to the fence. During the 2010/11 wet season the sections of fence were left erect for all cyclone events without being dropped.

Figure 4.14 Side view Fence through riparian vegetation. Untouched for 1½ years

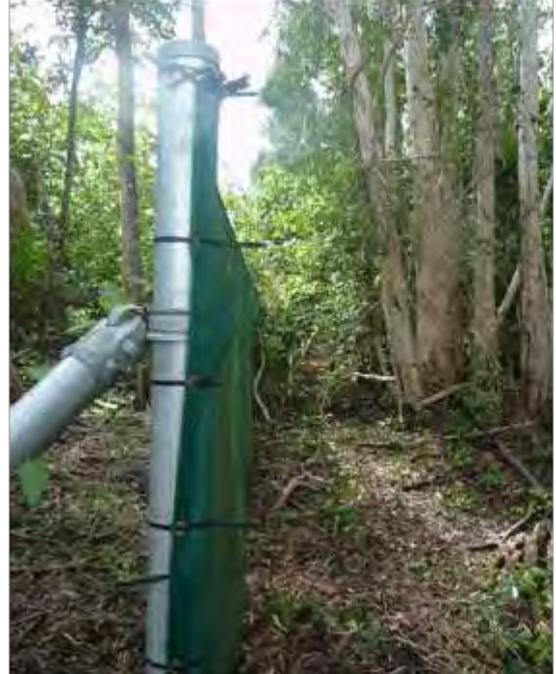
Figure 4.16 End View Fence through riparian vegetation Untouched for 1½ years

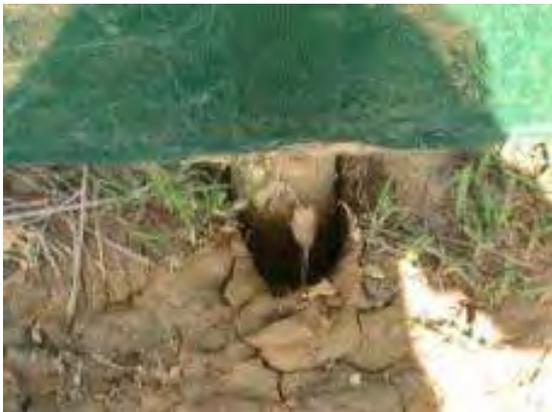
The 300m fence (4.18,19) showed loosening of the mid-span posts as a result of high wind events with peak gusts estimated at 60+km/h. Average windspeed data (5 minutes) collected from Ella Bay weather station on 15/03/2010 32+km/h, 22/10/2010 36+km/h, 25/12/2010 35+km/h, 23/01/2011 29+ km/h. The strong winds caused the shade cloth to act like a sail putting pressure on the posts.

The posts moved within the sandy soil. It was noted that even though the 300m fence was leaning to one side, very few clips were released and the tension of the wire held the integrity of the fence. Most importantly the fence remained secure.

Figure 4.18 Post movement from High wind

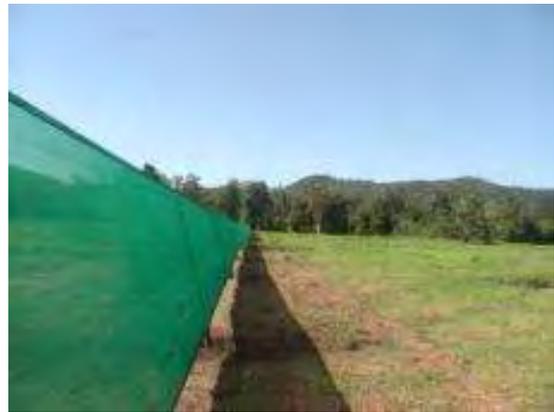
Figure 4.19 fence lay down from high wind

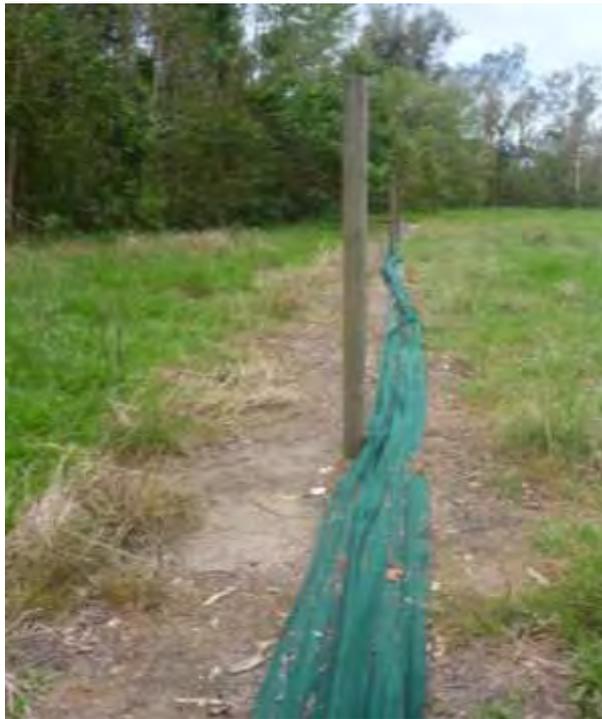
Figure 4.20 Cyclone Yasi 100m fence dropped and tied - no damage

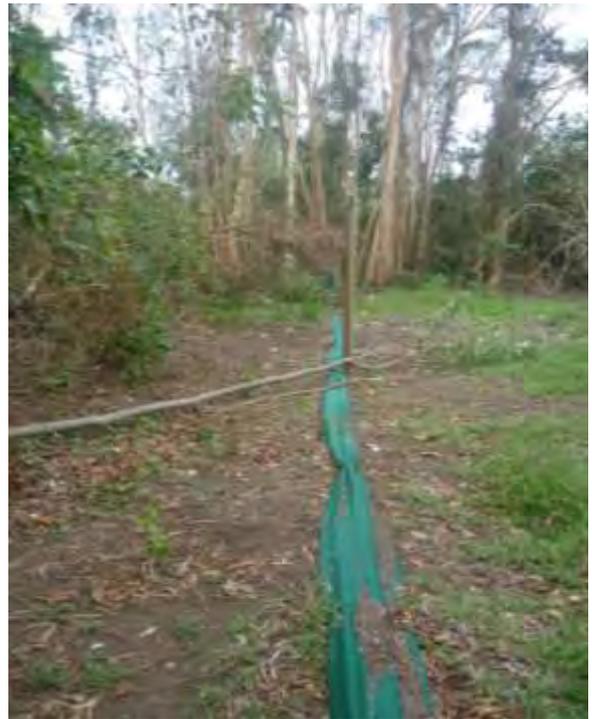
Figure 4.21 Cyclone Yasi 200m fence dropped and tied – no damage

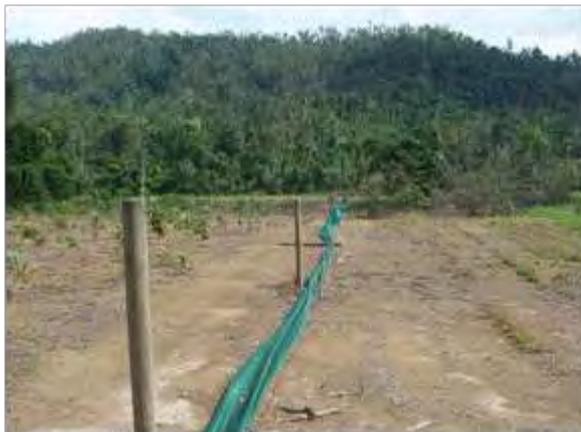
Figure 4.22 Cyclone Yasi 300m fence- south
No damage to shade cloth locally

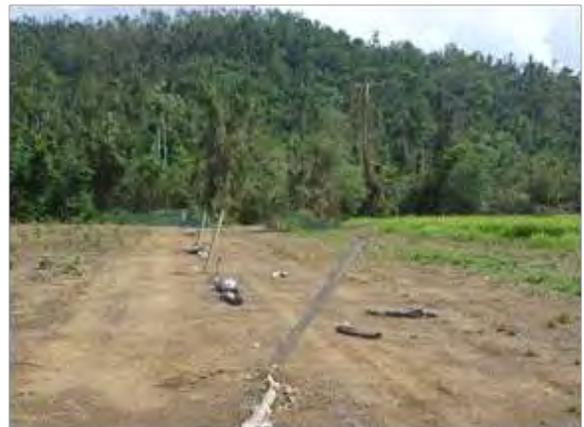
Figure 4.23 Cyclone Yasi 300m fence north.
Shade-cloth stripped and posts removed

At the northern end the fence near and within the vegetation performed well with no damage. The northern section of the fence from a mid point strainer was damaged by the breaking of the high tension wires and then flailing of the loose shade cloth with the wind. In all 8 posts were dislodged and swept away. The fence was extensively damaged for the last 50m with fraying of the shade cloth material.

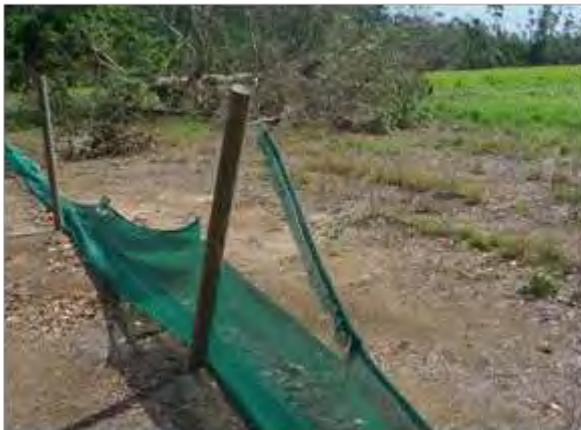
Figure 4.24 Cyclone Yasi 300m fence - south. Clip did not release and fence ripped

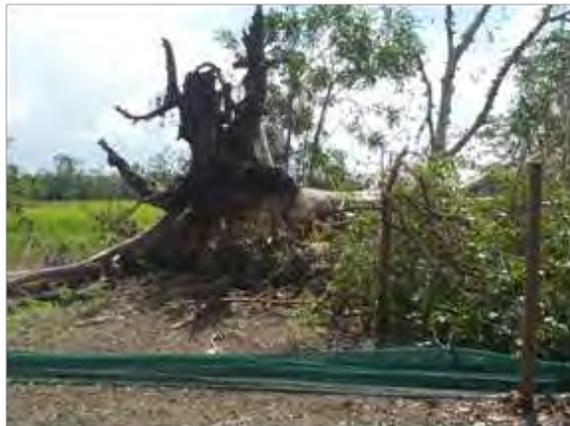
Figure 4.25 Cyclone Yasi 300m fence south. Tree up-rooted, no damage locally

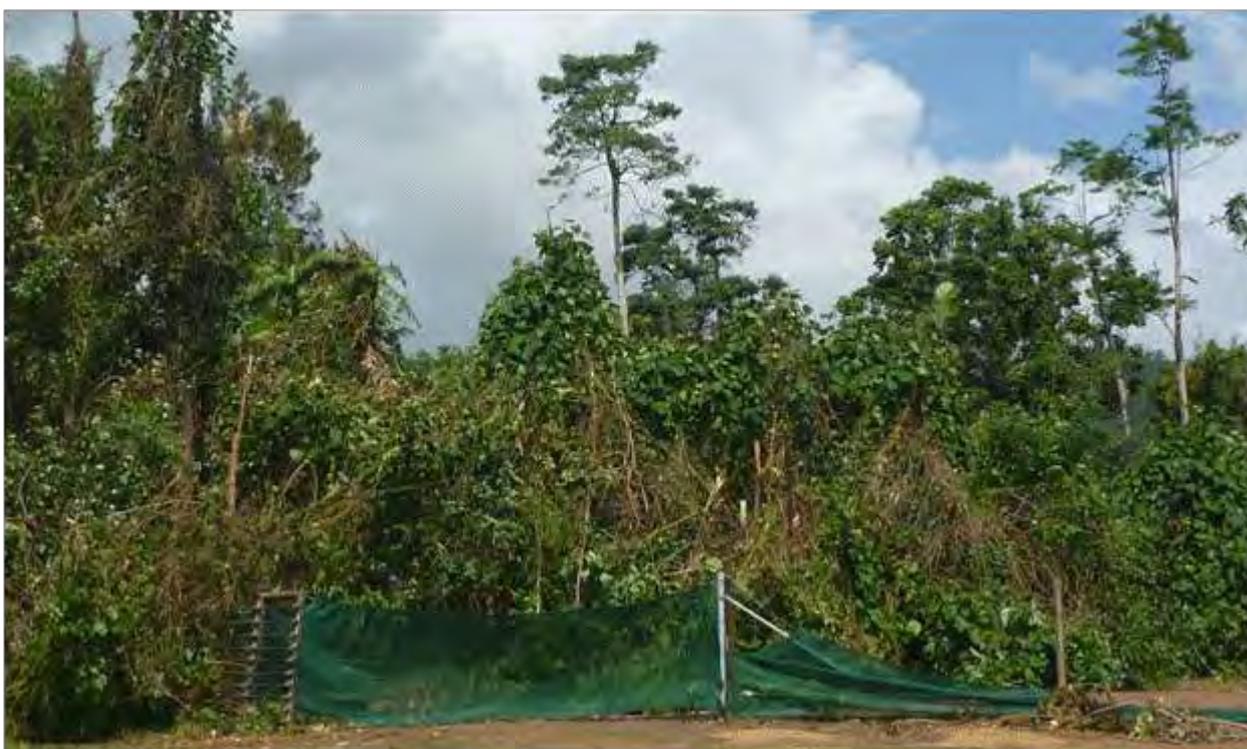
Figure 4.26 Cyclone Yasi 300m fence – Southern end. Cassowary gate and local shade cloth intact. Note vegetation damage behind fence.

The southern end was less damaged due to the predominant cyclone wind direction from the south. The shade cloth fence locally around the end strainer and the short length to the cassowary gate and within the vegetation were intact. The shade cloth was torn at attachment to the southern strainer assembly and at one mid-span post where the shear clip did not release. Only one mid-span post was dislodged. The vegetation damage directly behind the cassowary gate in Fig 4.26 is testament to the wind intensity.

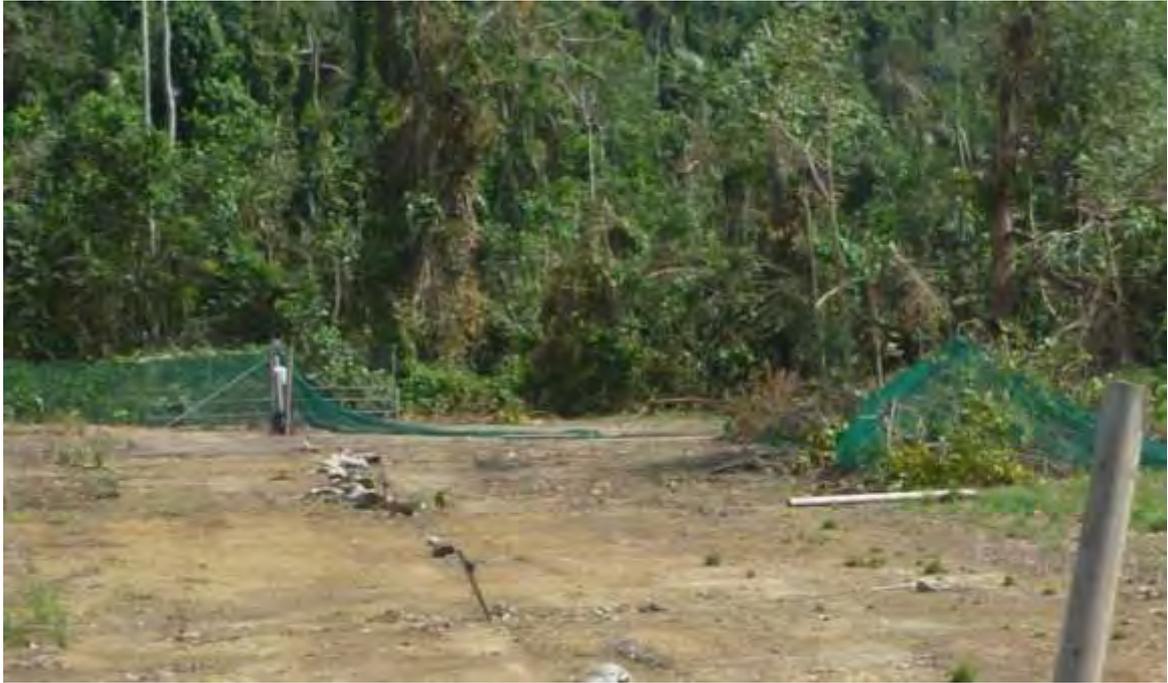
Figure 4.27 Cyclone Yasi 300m fence Northern end. Fence into the vegetation intact and undamaged. The section of fence and posts from the mid-strainer destroyed.

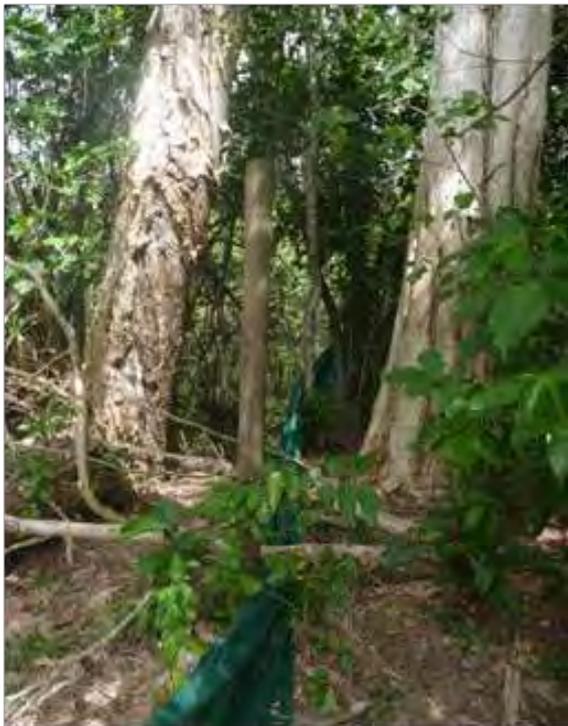
Figure 4.28 Cyclone Yasi 200m fence dropped and tied (no damage)

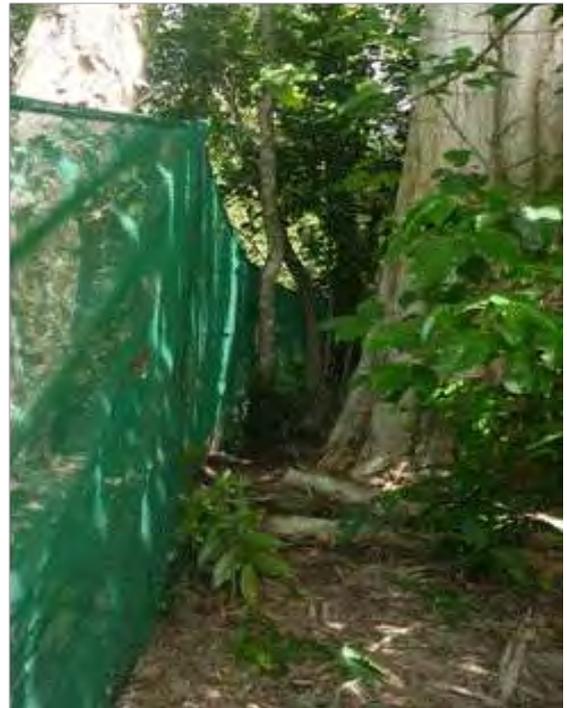
Figure 4.29 Cyclone Yasi 200m fence after re-clip showing minimal impact

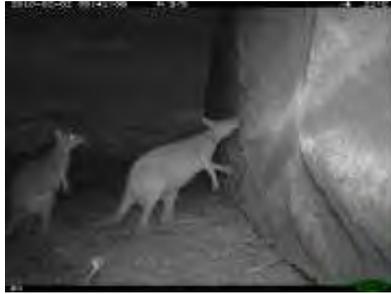
There are extensive numbers of Agile wallabies at Ella Bay and the grazing pressure in certain areas is extreme. The northwest revegetation area was home to between 50-100 wallabies and although initially sprayed with herbicide and laid fallow for over 6 months continued to attract wallabies to the area. The erection of the fence to exclude the wallabies and the planting of desirable palms and shrubs created a strong attraction for the wallabies such that they appeared to attack the fence. It was observed that the wallabies created many holes in the shadecloth material by jumping into the fence and damaging it with their hind claws or chewing and opening holes with their front paws on the fence. The wallabies were also found persistently digging the soft soil to make their way under the fence wire.

Figure 4.33 Wallaby attack on the fence

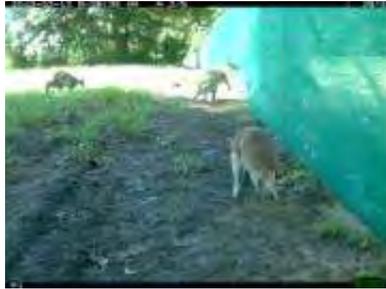
Figure 4.35 Wallabies grazing and chewing on fence

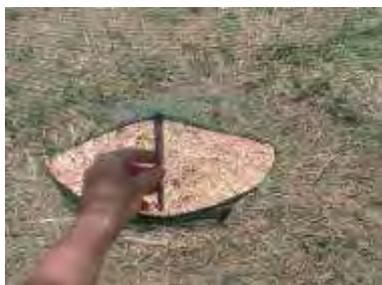
Figure 4.34 Hole from wallaby claw

The holes were repaired by hand stitching a shadecloth patch or silicone gel to bond the materials together and at some locations logs were placed along the fence where the terrain dipped and created a larger gap between the fence and ground to dissuade digging.

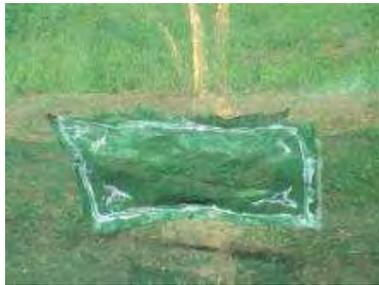
Figure 4.36 Temporary repair using glue on patch

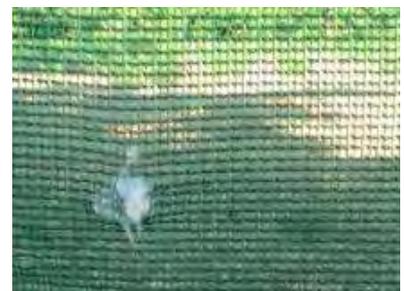
Figure 4.38 Temporary repair using silicone

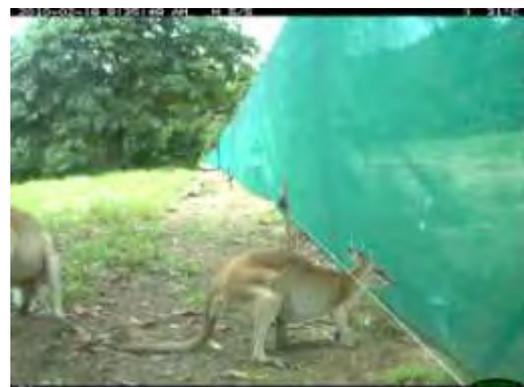
Figure 4.40 The deterrent has not worked
