6.5 d Beach Access Survey Report Ella Bay

Ella Bay Integrated Resort Proposal

SEIS Submission Response

Beach Access Report

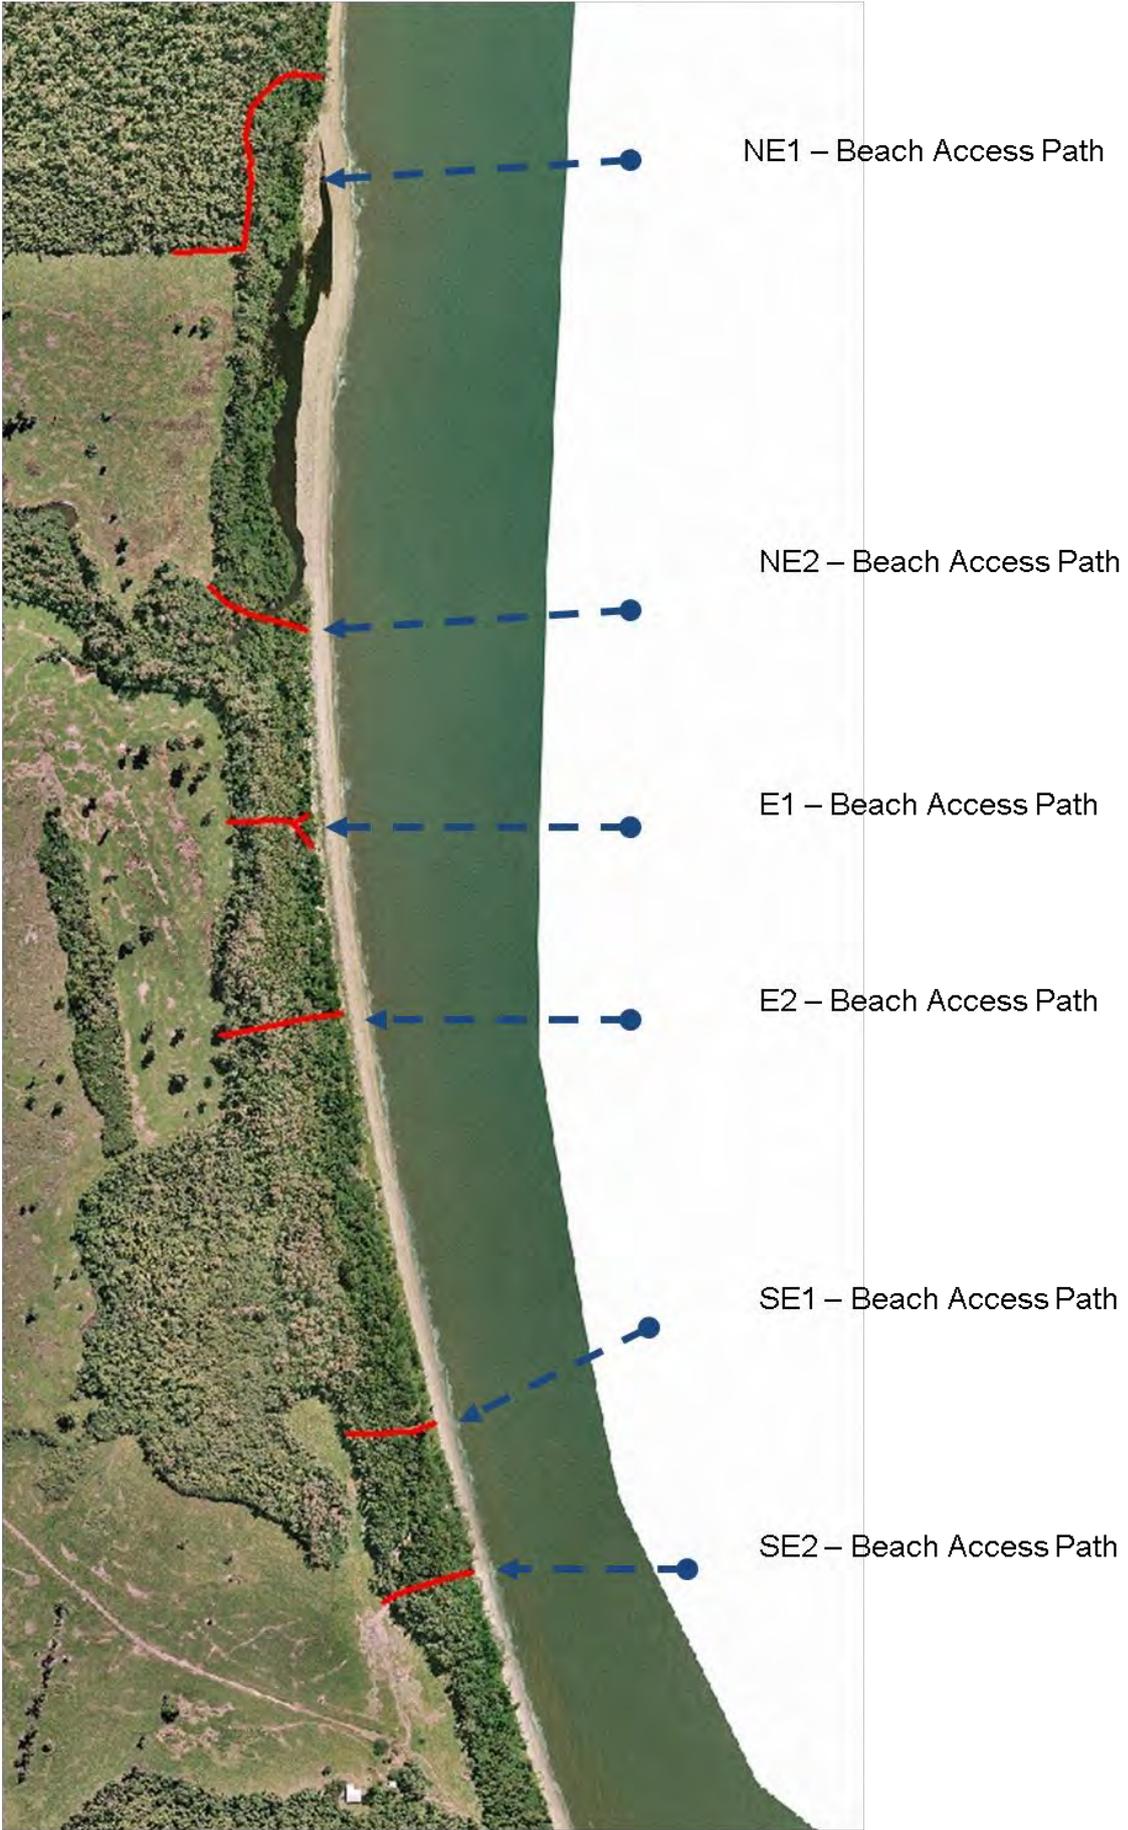
Figure 1.1 Beach Access Locations

There are six (6) surveyed locations for beach accesses. The access walks have been classified based on the "Track Classification System" by WTMA (2001). The six (6) beach access paths are illustrated in the figure 1.1.

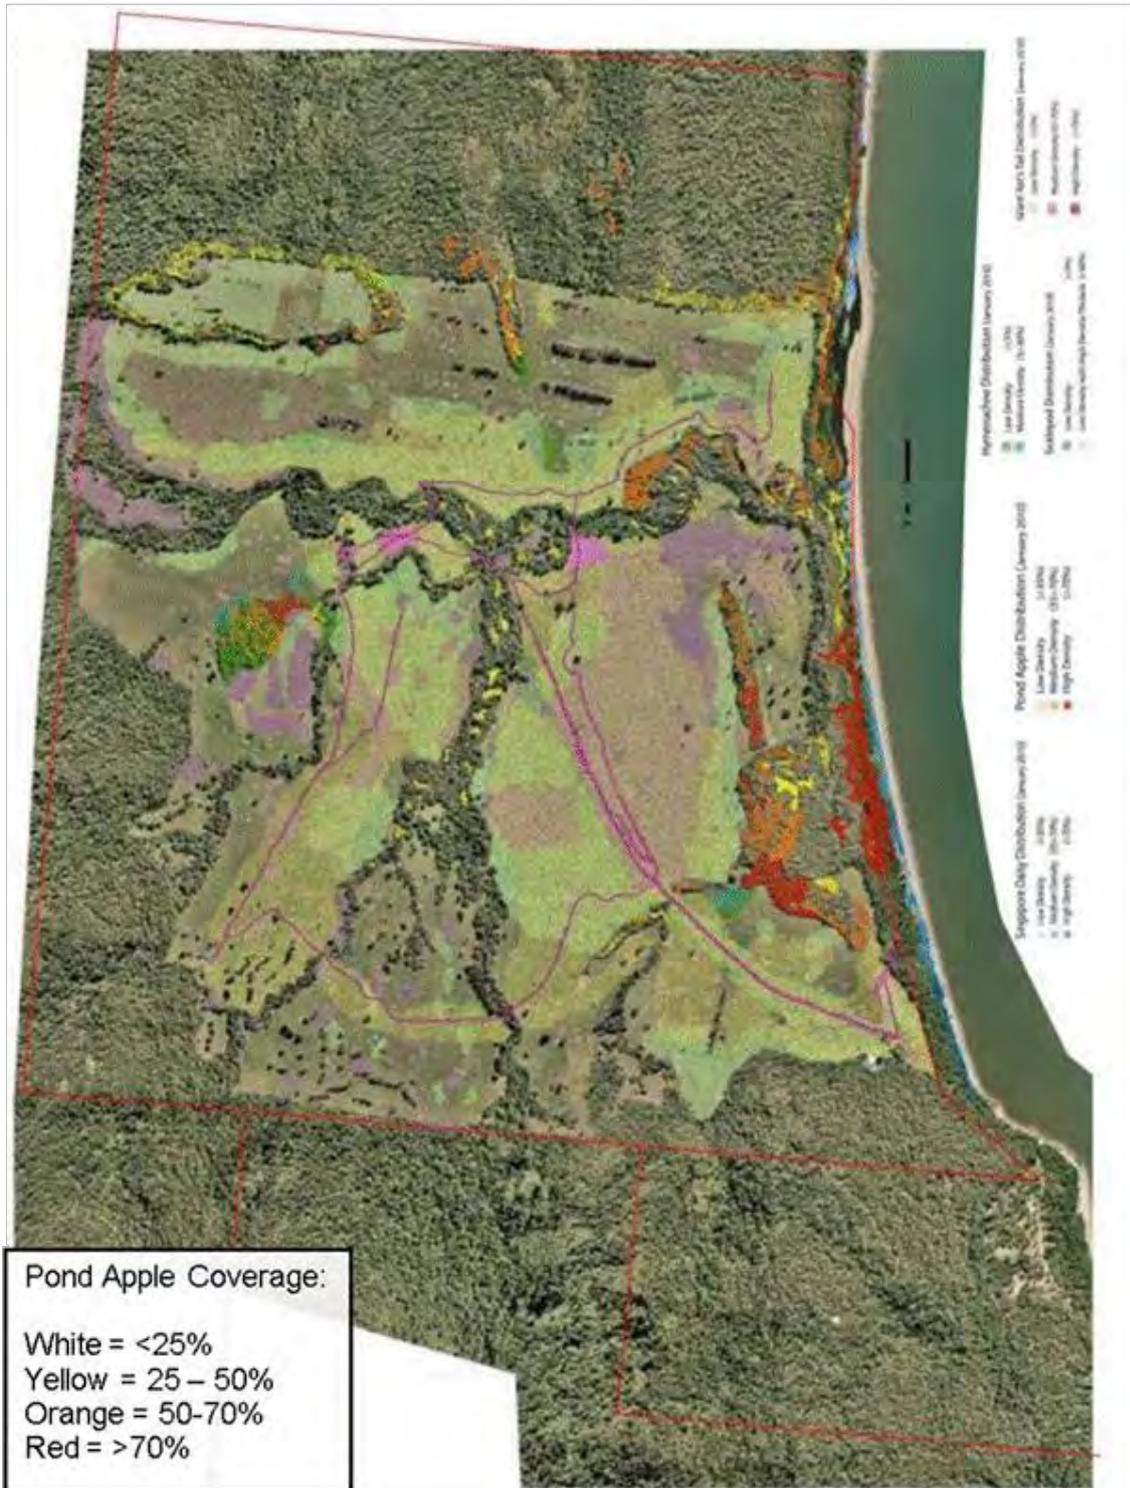
Figure 2.1 Weed Infestation mapping Jan 2010.

The existing coastal vegetation communities along Ella Bay are significantly degraded and subjected to high levels of weed invasion from previous farming practices, and seed dispersal through wind, sea, and animal transportation. The main weeds infestations identified at Ella Bay's **coastal region** are Pond Apple and Singapore Daisy. In January 2010 Ella Bay environmental staff conducted an extensive property weeds survey and the results are displayed in figure 2.1. (refer to Submission Response Volume 6.2 Weed Mapping Survey Jan 2010.

Pond Apple, is a declared Weed of National Significance (WONS) *Annona glabra* which has formed dense stands throughout this area with native habitat loss occurring through the suppression and replacement of native plant species. The survey determined the location and density of the Pond Apple within this area. The criteria identifies the lower canopy densities in the following categories: less than 35% (yellow); 35>70% (orange) and >70% (red).

Additionally *Urochloa maxima* (Guinea Grass) and *Allamanda cathartica* (Allamanda) pose a threat to trees located on the western edge of the coastal vegetation; and large swathes of *Sphagneticola trilobata* (Singapore Daisy) are found on the beachfront. The survey determined the location and density of Singapore Daisy within this area. Where the criteria identified the densities in the following categories: less than 35% (light blue); 35>70% (blue) and >70% (dark blue).

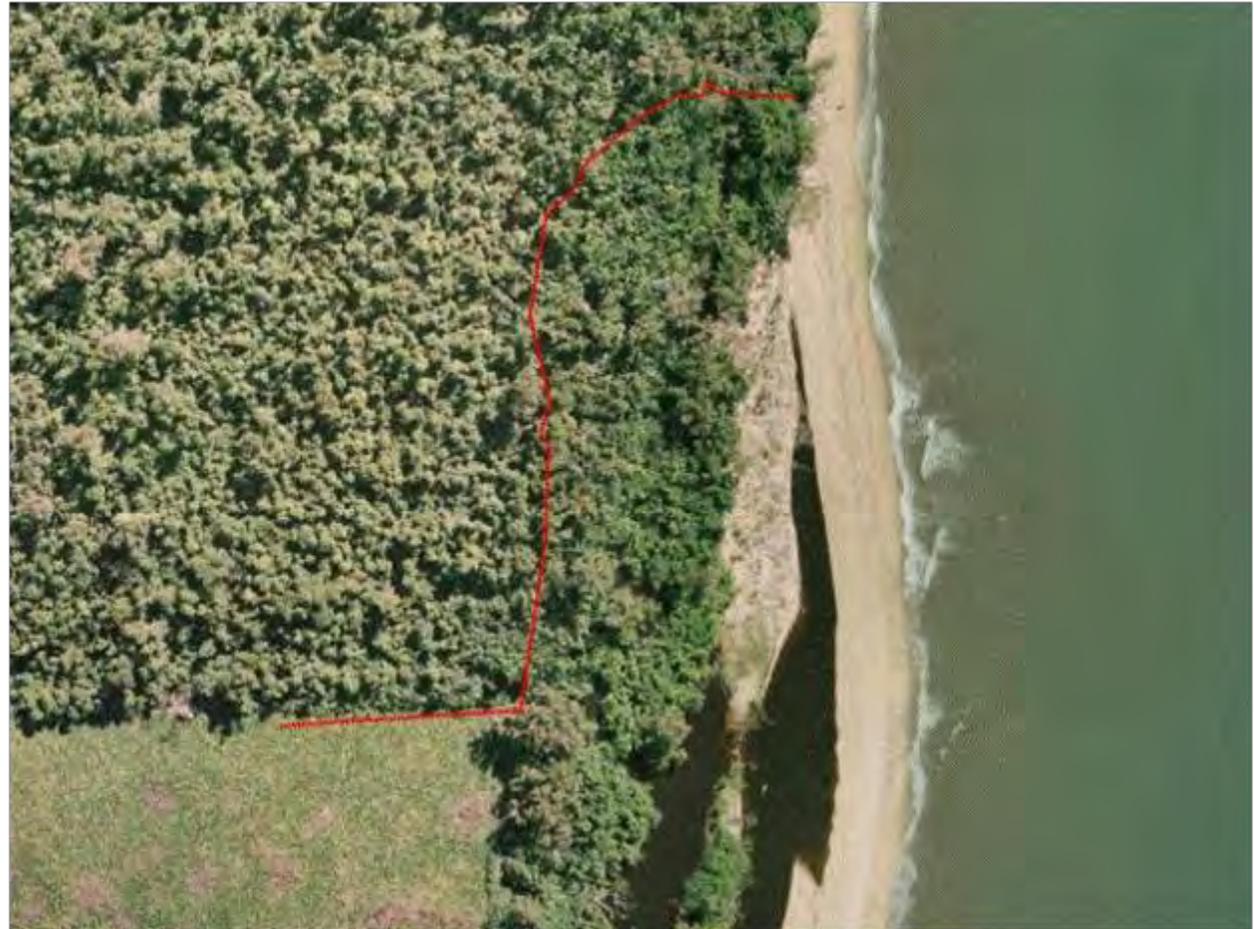
Figure 3.1 North Eastern Beach Access 1 – NE1

| Track name | NE1 |
|--|--|
| DESCRIPTION | The NE1 Beach Access will connect the upper most North East point of the proposed Ella Bay Development to Ella Bay beach via a scenic north-east hard surface and elevated boardwalk route. This beach access path will showcase unique Wet Tropics characteristics comprising of beachfront wetlands swale, mangrove and tropical rainforest vegetation and water crossings. Ella Bay has carefully chosen this path location in between where currently exists a low to medium density population of pond apple weeds on the western side and medium to large density of Singapore daisy weeds on the eastern beach side. Therefore making sure no native trees or mangroves will be destroyed and the location will be carefully revegetated with native trees. The initial 20% approx of the path will be via the proposed revegetation coastal buffer location which is currently open grass pasture. |
| Track formation & surface | Hardened surface 40% and boardwalk 60% approx. Suitable for all visitor access including wheelchair. |
| Track width (approx) | 2500 – 2000 mm |

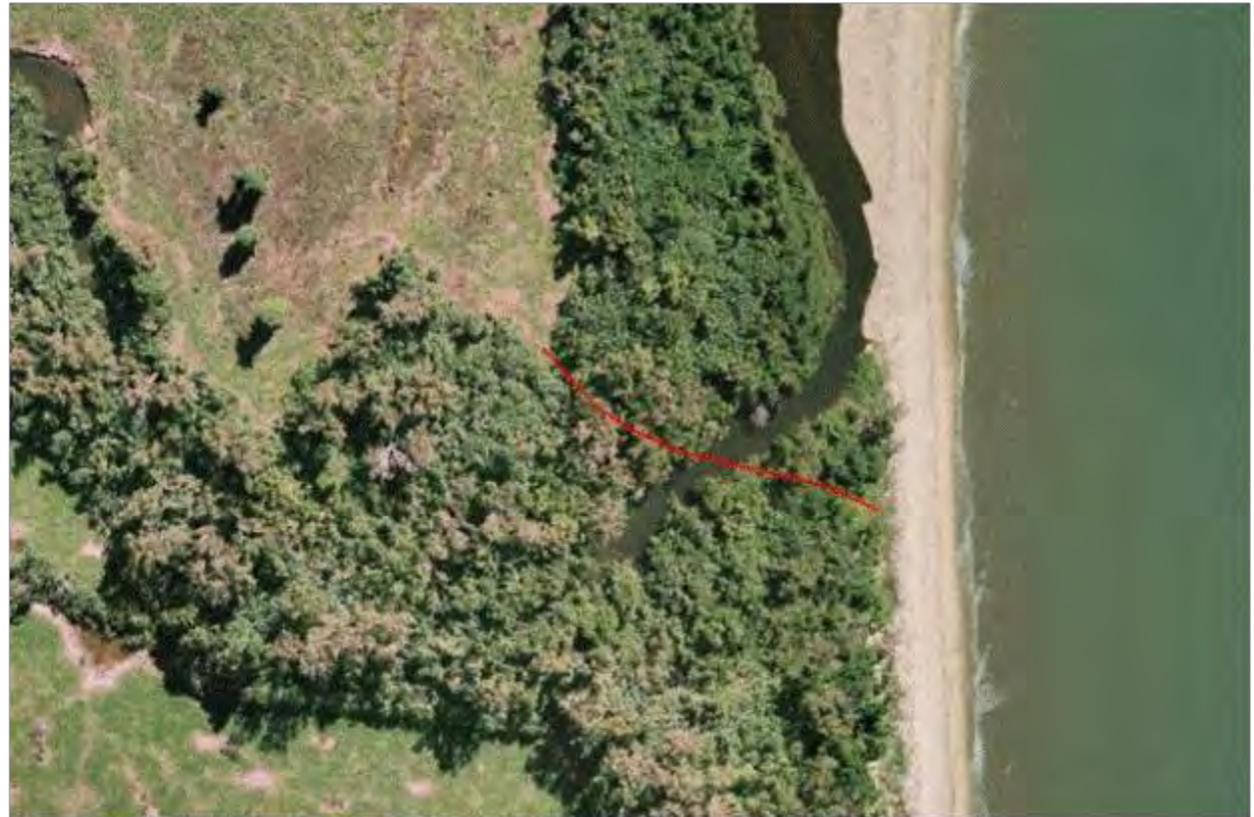
Figure 3,3 North Eastern Beach Access 2 – NE2

| Track name | NE2 |
|--|--|
| DESCRIPTION | The NE 2 Beach Access will connect access from the Northern Precinct of Ella Bay development through the coastal revegetation buffer over the beachfront wetlands swale to Ella Bay beach via a combination of hardened surface, elevated boardwalk over swampy areas and elevated bridge over the main creek. The path has been chosen in an area with minimum disturbance to the current environment. This path will be via the proposed revegetated area buffer, in between a medium density population of pond apple which will be revegetated with native trees and bridge over the creek which will be designed to conform to wet and dry season conditions. There is the presence of mangroves around this path area especially near creek banks; however the path will be designed and constructed around established mangrove trees with minimal disruption to the vegetation. This pathway access point is very important as it will act as prevention to uncontrolled access via other locations for the area especially the constantly moving dunal swale. |
| Track formation & surface | Hardened surface 25%, boardwalk 65% and elevated bridge structure 10% approx. Suitable for all visitor access including wheelchair. |
| Track width (approx) | 2500 – 1750 mm |

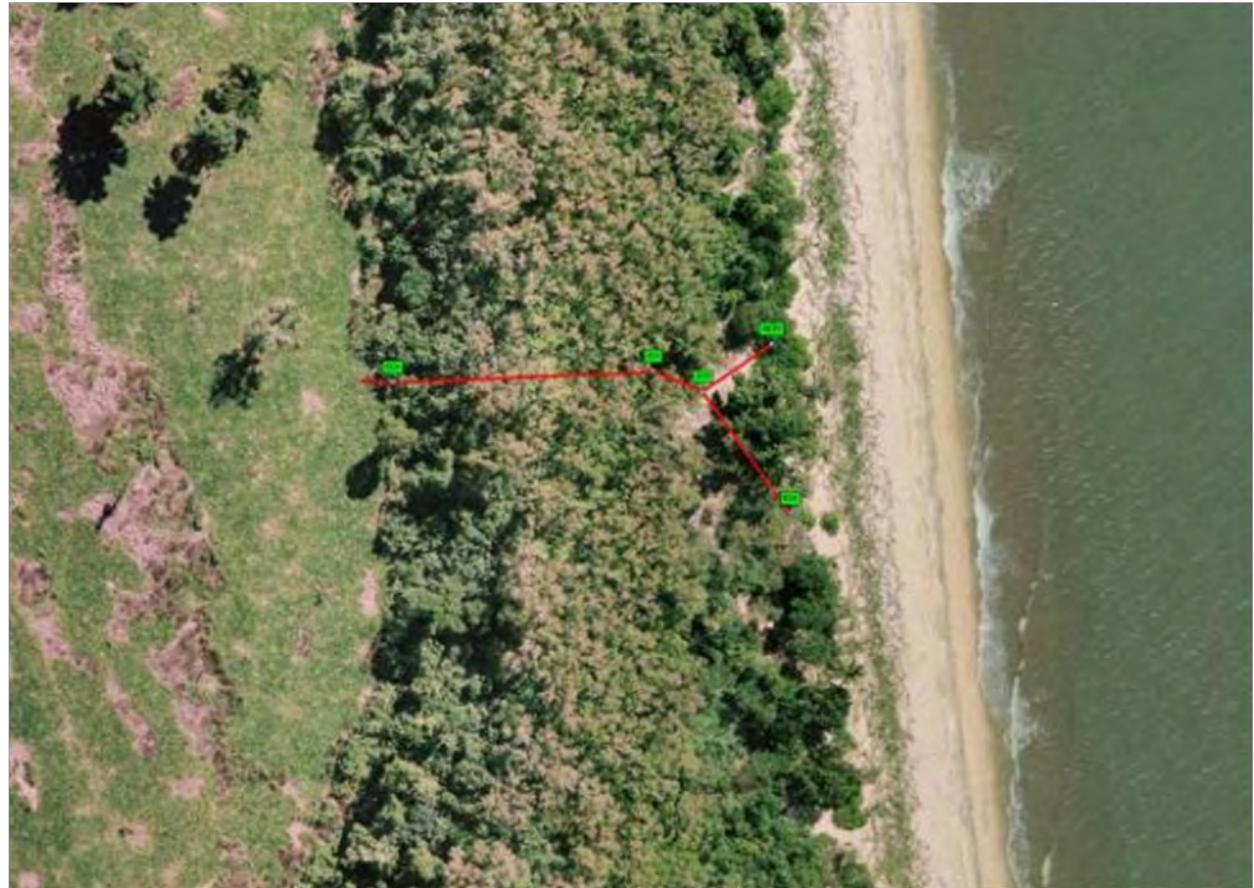
Figure 3.4 Eastern Beach Access 1 – E1

| Track name | E1 |
|--|--|
| DESCRIPTION | The E1 Beach Access will connect the pedestrian access from the eastern development site to the beach via boardwalk which will be elevated over the dunal swamp swale system. This location has been chosen along a thick stand of pond apple. The pond apple will be felled and the path constructed after its removal. There will be no damage to any native mangrove trees or other significant species. This path, although short will be within a picturesque rainforest wetland location as it meets the beach front. This path will be important to stop unauthorised visitor movement into other areas within the swale. |
| Track formation & surface | Hardened surface 20%, boardwalk 65% and sandy surface 15% approx. Suitable all access including wheelchair. Wheelchair access to edge of sandy surface, but may consider timber board options at sand. |
| Track width (approx) | 2500 – 2000 mm |

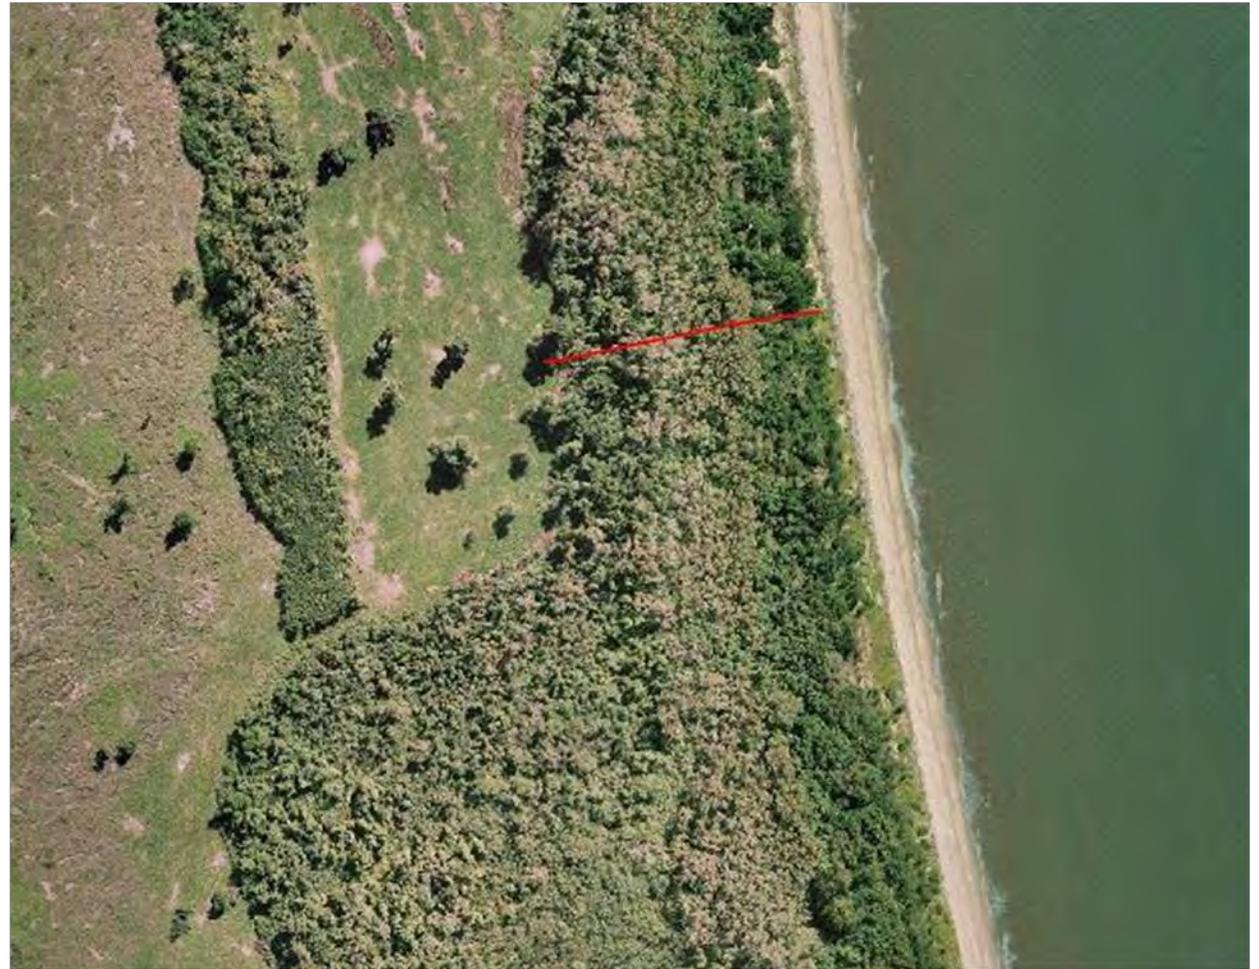
Figure 3.5 Eastern Beach Access 2 – E2

| Track name | E2 |
|--|---|
| DESCRIPTION | Similar to the E1 Beach Access, E2 Beach Access will connect the pedestrian access from the Central Resort site to the beach via a boardwalk which is elevated over the dunal swale. The location of E1 and E2 have been chosen to be one third and two thirds along the central area to distribute pedestrian traffic to minimise disturbance. This beach access also has large stands of pond apple along the route. The pond apple will be felled and the path constructed after its removal. There will be no damage to any native mangrove trees or other significant species. This path, although short will be within a picturesque rainforest wetland location as it meets the beach front. |
| Track formation & surface | Hardened surface 20%, boardwalk 70% and sandy surface 10% approx. Suitable all access including wheelchair. Wheelchair access to edge of sandy surface, but may consider timber board options at sand. |
| Track width (approx) | 2500 – 1750 mm |

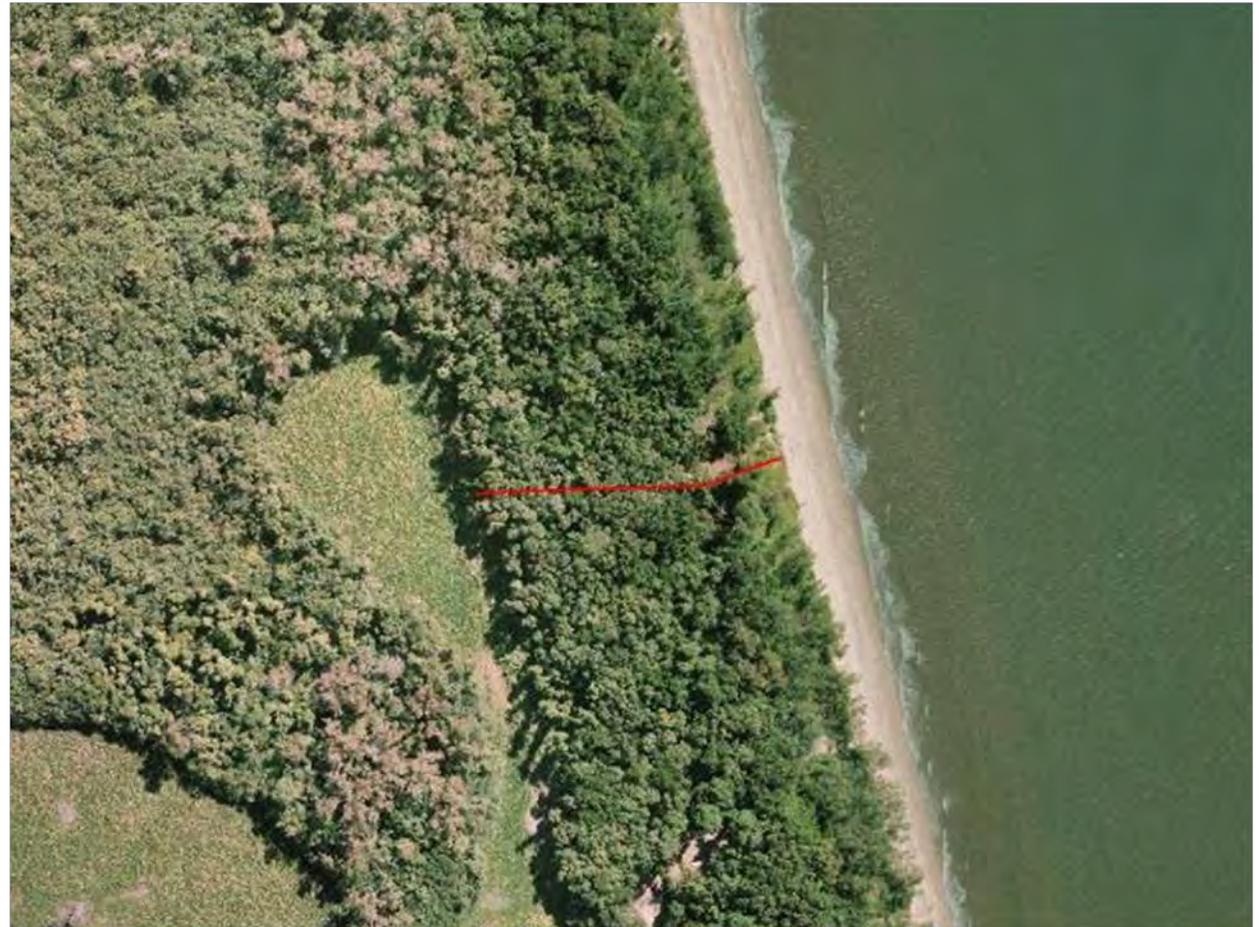
Figure 3.6 South Eastern Beach Access 1 – SE1

| Track name | SE1 |
|--|---|
| DESCRIPTION | The SE1 beach access has been chosen along an existing cleared path to the beach. No clearing of significant trees or species will be required. The path will be hard stand with no elevated structures. It is expected that there will be a low number of visitors accessing this path and will cause minimal impact to the environment. |
| Track formation & surface | Hardened surface 75% and sandy surface 25% approx. Suitable all access including wheelchair. Wheelchair access to edge of sandy surface. |
| Track width (approx) | 2000 - 1750mm |

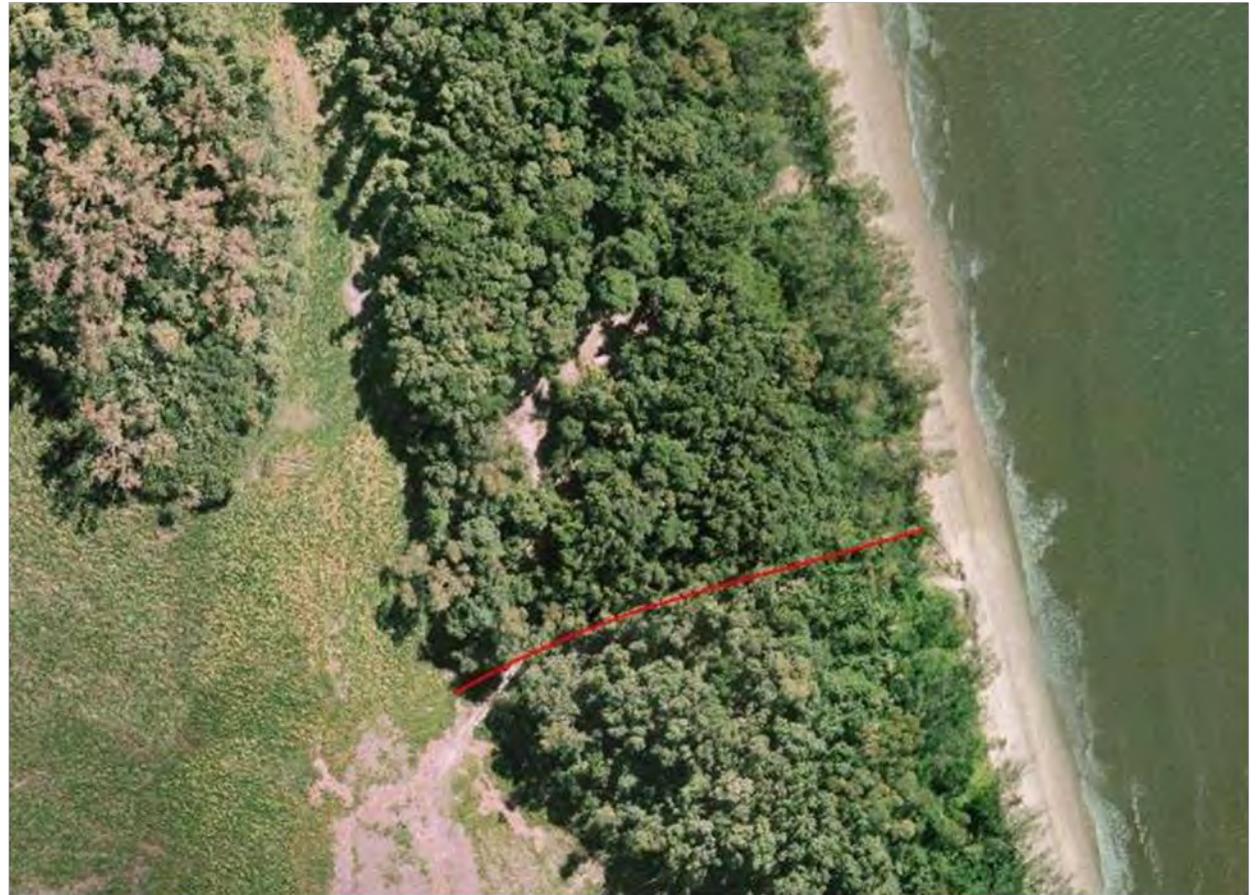
Figure 3.7 South Eastern Beach Access 2 – SE2

| Track name | SE2 |
|--|--|
| DESCRIPTION | The SE2 Beach Access path will be the main access point for visitors and public. It will include access for emergency vehicle to the beach front. There is an existing wide cleared path to the beach area via an old fisherman's hut. The fisherman's hut and amenities will be removed and the area rehabilitated and revegetated. The path will be constructed within the existing cleared area in a more direct line to the beach. The canopy is open and trees are spaced apart. Some hand clearing will be required but no major species or significant species will be cleared. |
| Track formation & surface | Hardened surface, Suitable all access including wheelchair and emergency vehicles. |
| Track width (approx) | 2500 mm |
