Ella Bay Road Underpass Design

Cassowary Road Crossings Survey

October 2009 Revision 1

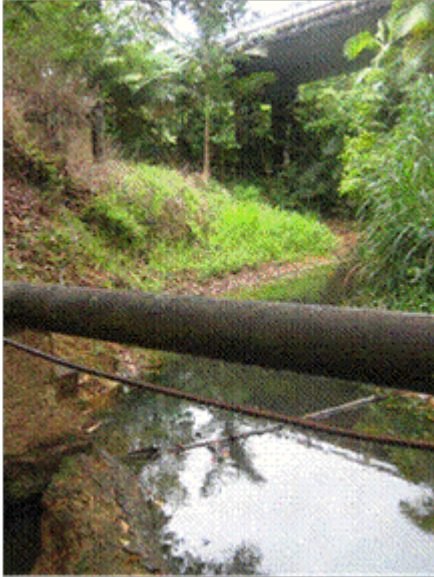
:][i fY' & % BcfH ' < i `` 6 f]X[Y'CW" & \$ \$, "

@WUjcb' bZfa Ujcb. The North Hull Bridge is a three span bridge about six metres above the North Hull river stream. During all visits the river had a small constant water flow and conditions were cool and moist. There is no fencing or funnelling strategy at this location, however the area under the bridge and its surrounding was initially reshaped and vegetated for the purpose of fauna movement. However, it was noticed at the second visit (November 2008) many of the trees and palms planted for wildlife were cut down or poisoned as part of presumed maintenance regime.

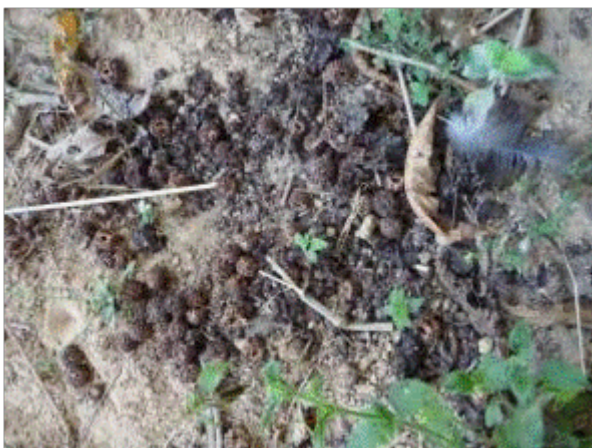
:][i fY' & ' C'X'gWUjcb' YUghVUb_ " = g'Wt bHbhi
k Ug'a cghime i UbXcb['gYXg"

7 Uggck Ufm9 j]XYbWV. Evidence of Cassowary traffic under this bridge was found only in the presence of scattered scats during the October 2008 visit. The scats were old; one scat was located on the east bank, two on the west bank and one on the northern approach.

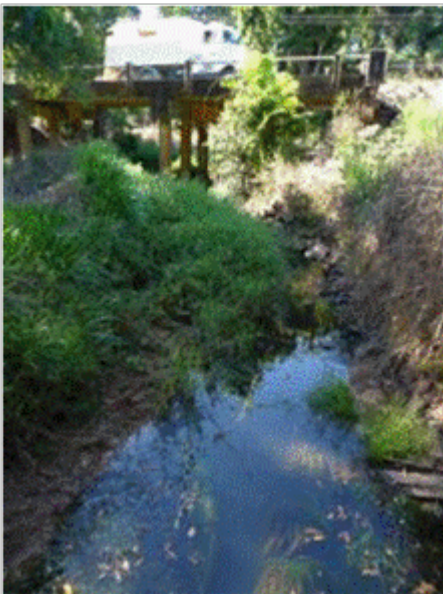
:][i fY&*' K cb[U]b['7fYY_ '6f]X[Y'CWi&\$\$, "

@WUjcb' bZfa Ujcb. The Wongaling Creek Bridge is a three span bridge about 3.5 metres above the Wongaling Creek on the El Arish Rd. During the first visit (October 2008) the creek had low flows and conditions were cool and moist. During the second visit (November 2008) there was no water flow. The surface was boggy mud with recently poisoned grass within the water course. There is no fencing or funnelling strategy at this location. The creek banks and vegetation on banks are poor with no canopy cover over the creek which creates an open space and is the only method of path under the bridge that cassowaries can use.

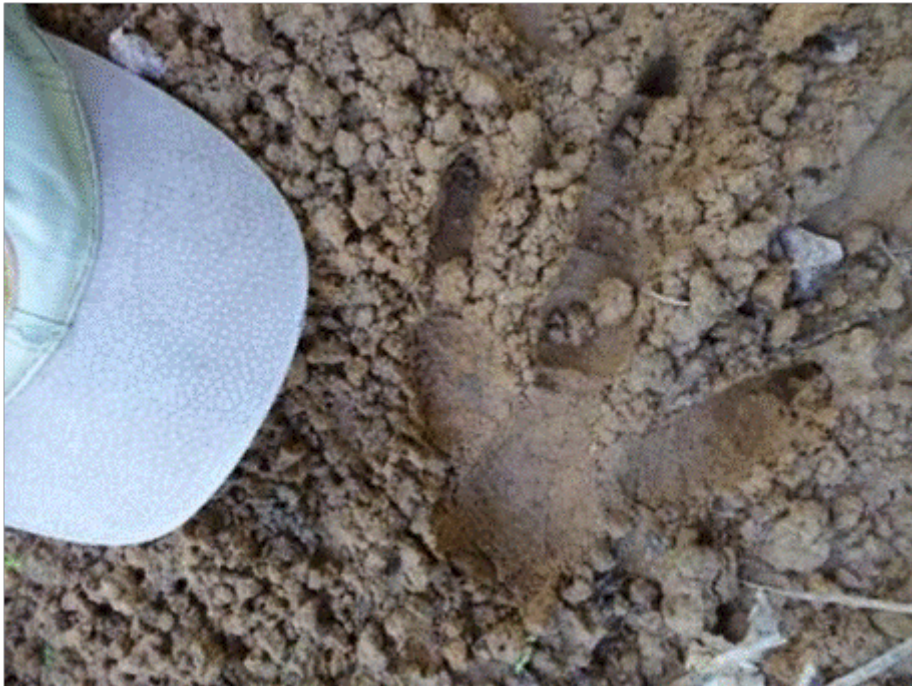
: J[i fY`&`,` ; ccX`ei U]hmidf]bhi bXYf`Vf]X[YfB%`E`&\$\$a a L"

7 Uggck Ufni9 j JXYbWV. Evidence of Cassowary traffic under this bridge was found at all visits in the form of footprint tracks from different sized animals.
