6.1 i Cassowary Gate Trial 2009 Ella Bay

Cassowary Escape Gate Trials

Johnson River Crocodile Farm

December 2009 Revision 1

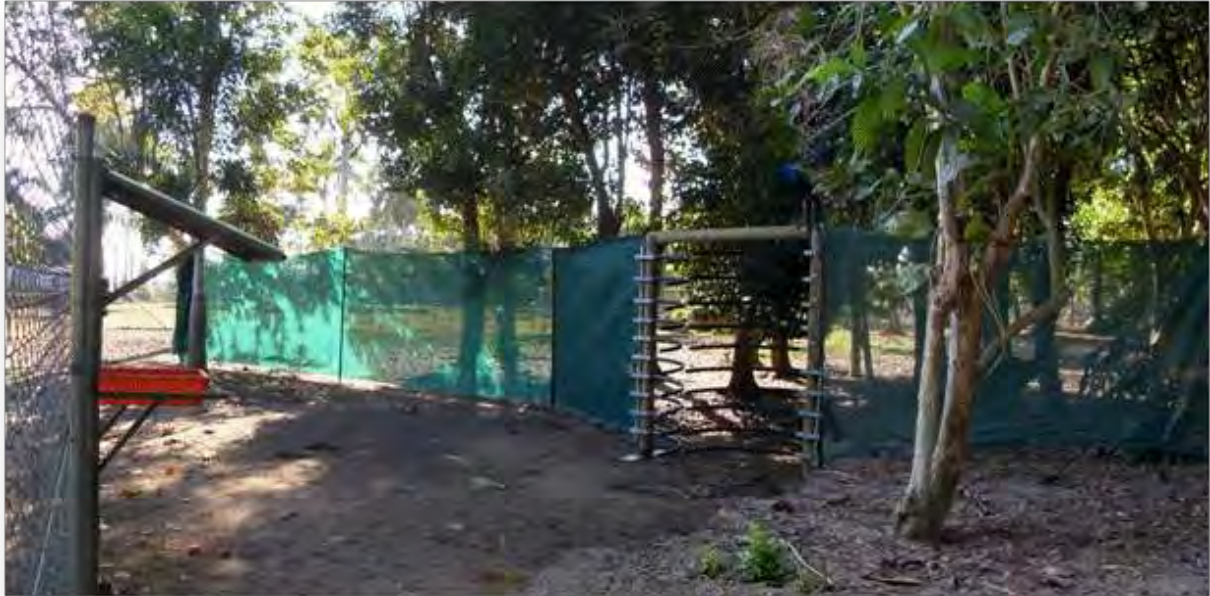
The trial site was established within a corner of the enclosure which included the only feeding station for the birds. It created a small internal yard, triangular in shape, bound on two sides by the existing chain wire fence, with the third side consisting of the constructed 1.8m high shadecloth directional fence which incorporated the one way escape gate.

Figure 2: Photo showing the ‘trial area’ within the cassowary enclosure, feed station on the left

The gate was constructed to fit inside a 1.8m high tensioned shadecloth directional fence (Figure 2). The outer frame opening was 1.5m wide providing a theoretical maximum visual window of 1.8m x 1.5m. The gap between ‘fingers’ both vertically and horizontally could be adjusted in the trial to optimise the ‘clear line of sight’ for the birds to encourage entry. Initially the gap was set 100mm between the ball ends of the fingers. Visually the gate was designed to appear as open as possible; particularly in contrast to the shadecloth fence on either side. Figure 1 shows the food trough is clearly visible through the gate.

Typically, directional fencing is 1.8m to 2.4m high using wire cyclone mesh fence material. This open mesh fence does not provide a significant differential appearance between the fence and the escape gate. Also the type of fencing is not suitable for all fauna with the potential for harm being caused by trapped/snagged limbs. Cyclone fencing has been used with cassowaries in a number of places with negative results leading to injury and possible death. The directional fencing used in the trial was based on shadecloth having a shade factor of 50% to restrict the visibility of the bird through the fence and enhance the visual cues of the escape gate. The shadecloth was also chosen due to its soft impact to minimise injury to the birds. The fence was constructed with a local funnel arrangement into the gate frame to focus the birds as they moved along the fence (Figure 2).

The primary aim of this trial was to determine whether a cassowary could and would voluntarily use the one-way gate. As illustrated in Figure 2 and 3, the fence and gate were constructed around the cassowaries' only feeding trough. They are routinely fed fresh seasonal fruit every morning around 8am. This practice was continued throughout the full period of the trials with the food being replaced everyday. It was identified prior to the trial that food would be the motivational factor as no other practical options were available, suitable or free of harm. The layout and specifications of Trial 1 are shown in Figure 3 illustrating the locations of the Reconyx motion cameras, all of which were positioned to point at the one-way gate.

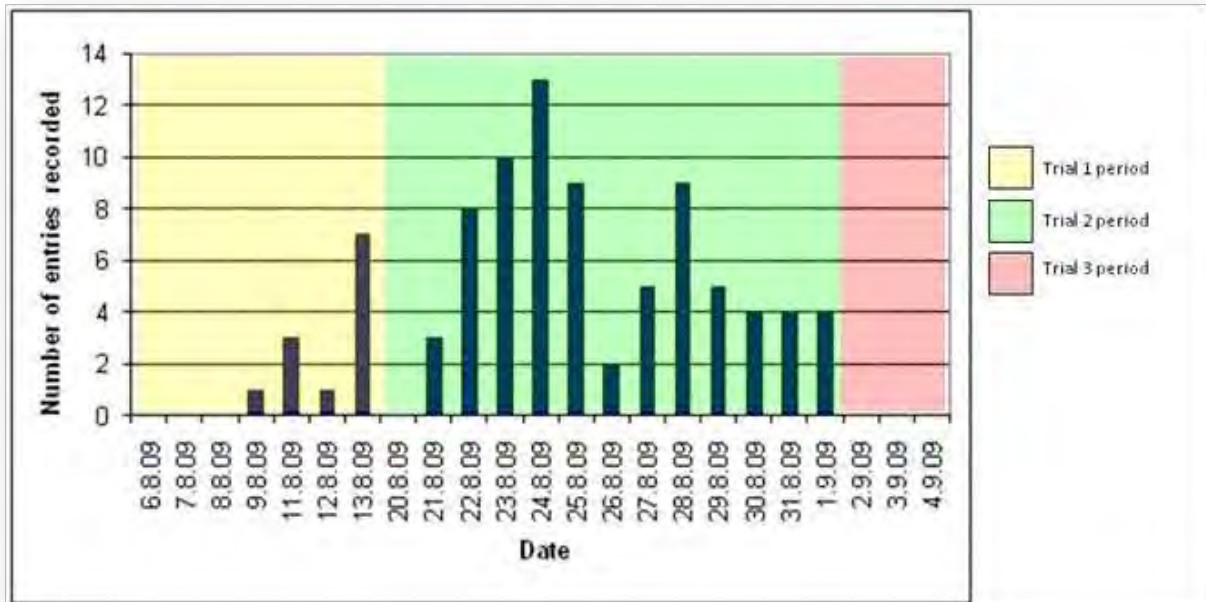
September 2009. Altogether, there were 88 photographic records of the cassowaries entering the one-way gate. Of these, there were similar records of either bird entering the gate, suggesting that neither bird was more disposed than the other to use the gate. Initially only one camera was installed, which had difficulty obtaining images of the birds within the gate area due to a time lag on firing and suffered from continual battery failure. Further cameras were installed during trial 2 however a total period of 7 days was not photographically recorded. Taking into account an average of 4 entries per day during this period the total usage would have been greater 116 passages through the gate.

Figure 5: The number of gate entries recorded on each day that data was obtained. No pattern was observed in the frequency of use of the one-way gate over the period of the first two trials.

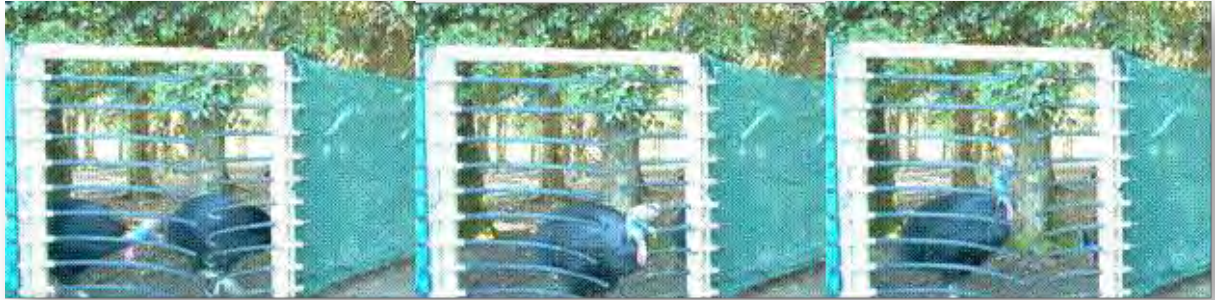
Both birds appeared reluctant to use the gate during the first two days. On 7 August 2009 Wally attempted to enter the gate. However, he withdrew before passing through, as shown

in the series of photos in Figure 7. Discussion of this behaviour is addressed in the following section.

Figure 7: Series of sequential photos (07.08.09) showing Wally attempting to enter the gate and then withdrawing.

The strategy of using a shadecloth fence as directional fencing providing a visual cue to the gate and the funnel entrance to the gate, was demonstrated as effective from the start of the trials as the cassowaries immediately lined up to the escape gate as a means of access to their food supply. This is an important and significant observation as the cassowaries were captive in a cyclone mesh compound and the birds had no previous exposure to gates or a shadecloth fence. The birds' behaviour when introduced to the fence and gate differed to their normal behaviour when walking the compound mesh fence. Their normal behaviour with the compound mesh fence was a stereotypical caged pacing behaviour a set distance from the fence occasionally rubbing against the fence. The initial cassowary behaviour to the shadecloth fence and one-way escape gate was different in that the birds immediately differentiated the shadecloth fence to the gate and inquisitively moved towards the gate as the means of moving towards their food. The cassowaries could see the food container and tried the direct route to their food source through the gate. The birds walked up to the gate and moved towards the local funnel entry but stood away from the gate moving from side to side about the opening unsure as to whether they could enter. This behaviour was repeated frequently during the first two days, sometimes only minutes apart. The frequency was increased between dawn and the normal feeding time of 8:00am. Each time the birds would go into the funnel entry and investigate the escape gate from about 0.5 metre and not take the next step into the gate. Only one attempt at entering the gate was observed during the first two days: Henry pushed his neck forward in to the opening and then retreated.

It was particularly important to demonstrate that the one-way gate would operate safely should a cassowary withdraw after initiating entry. Safe withdrawal from the gate was demonstrated on two occasions during this study, resulting in no negative experience. Throughout the risk assessment process undertaken in both the design phase and preparation for the study it was imperative to confirm through a controlled trial situation that the gate was safe to be used by a cassowary.

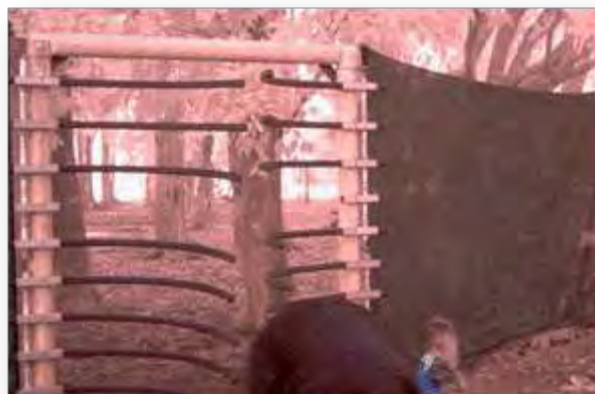
On 9 August 2009, the gate was modified to encourage use by the cassowaries. The pair of fingers in the fourth row were removed to create a visual window for the birds. In addition, the gap between each pair of fingers (shown as the horizontal space between opposing fingers in Figure 1) was widened from 100mm to 200mm, again, creating a better visual window to encourage entry. Three minutes after these adjustments were made, Henry entered the gate. This first entry occurred 66 hours after the gate and fence were initially installed around the cassowaries' feeding trough.

Figure 8 shows the first gate entry. As can be seen by Henry's position as he entered the gate, his head and neck remained well below the gap created by removal of the fourth pair of fingers. This indicated that it was the widening of the horizontal space between opposing fingers to 200mm, rather than removal of the pair of fingers which encouraged the entry.

Figure 8: Photo (09.08.09) showing Henry entering the gate for the first time. Note his head and neck entry position well below the space created through removal of the fourth pair of fingers.

The fourth pair of fingers was reinstated after one hour. The cassowary's continued use of the gate after this provided further support for the importance of the horizontal space between opposing fingers in stimulating entry.

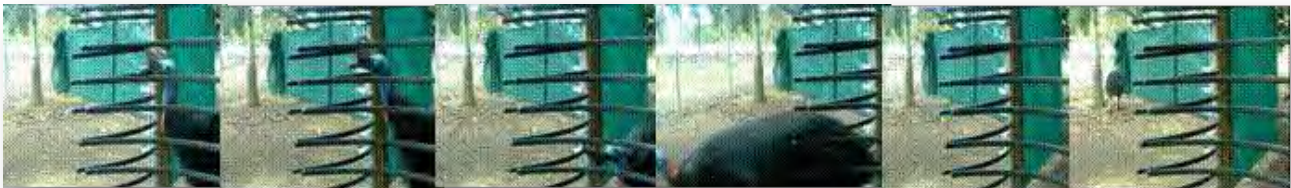
The series of photos in Figure 9 show Wally entering the one-way gate and exiting the food enclosure via the alternative access point.

Figure 9: Series of sequential photos (02.09.09) showing Wally entering the one-way gate and exiting via the alternative access point.

In Trial 2 it was demonstrated that the birds chose to use the one-way gate even when an alternative entry point was made available. The cassowaries predominantly entered through the escape gate and exited through the open part of the fence. This result established that the cassowaries were not averse to using the gate, and used it as a normal part of their environment. A possible explanation is that access through the one-way gate was the only visual means from the main enclosure, and would have provided the closest point of access to the cassowaries feeding station. However, as the birds exited through the opening in the

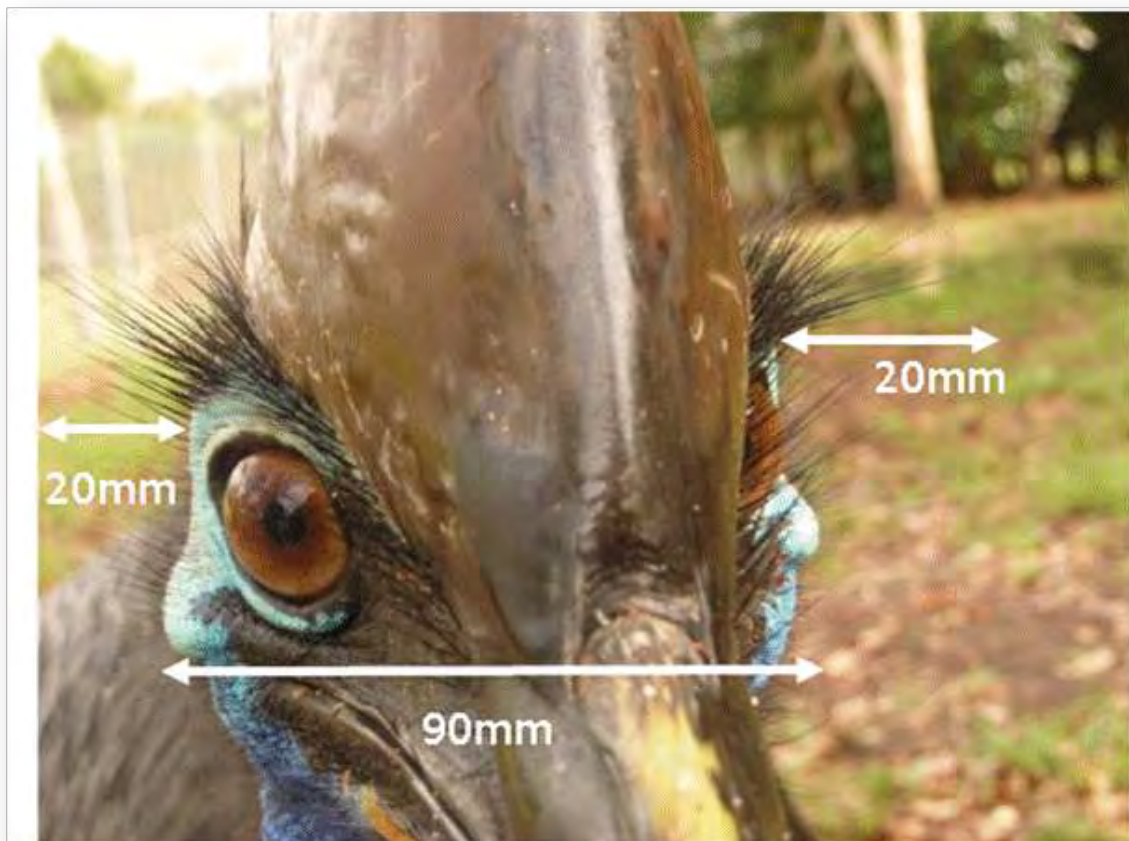
It is hypothesised that the vertical gap may in fact need to be a certain width before cassowaries feel comfortable enough to enter. Cassowaries have an array of numerous facial whiskers on their upper mandible around their eyes known as rictal bristles. Rictal bristles are thought to have a sensory function to determine proximity similar to the vibrissae in many mammals, e.g. cats (Lederer 1972) The measured dimensions of the birds head was 90mm in width with 20mm of whisker extension each side providing an overall width of 130mm, slightly greater than the initial vertical gap of the fingers. This logic appears even more likely when observing the slender vertically compressed profile of the body beneath the feathers.

Figure 10: Cassowary rictal bristle dimensions
