6.1 j Cassowary Fence Trial 2010 Ella Bay

Report on
Cassowary Exclusion Fence Trials
At
Ella Bay

July 2011 Revision 2

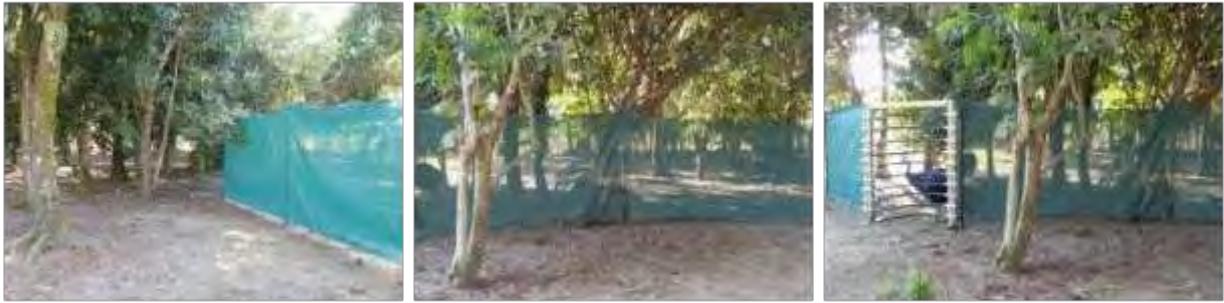
Figure 4.1 Trial #1 Fence and Cassowary Gate

The shadecloth fence worked well as directional fencing providing a visual cue to the gate and the funnel entrance to the gate. This was demonstrated as effective from the start of the trials as the cassowaries immediately lined up to the escape gate as a means of access to their food supply. This is an important and significant observation as the cassowaries were captive in a cyclone mesh compound and the birds had no previous exposure to gates or a shadecloth fence. The birds' behaviour when introduced to the fence and gate differed to their normal behaviour when walking the compound mesh fence with the birds immediately differentiating the shadecloth fence to the gate and inquisitively moving towards the gate as the means of accessing their food. The cassowaries could see the food container and tried the direct route to their food source through the gate.

There was no sign of the cassowaries wanting to push through the fence which indicated it acted as an effective visual barrier. The fence was also effective as an injury reduction barrier with a bird on one occasion being startled and running into the fence and bouncing backwards from the taut material.

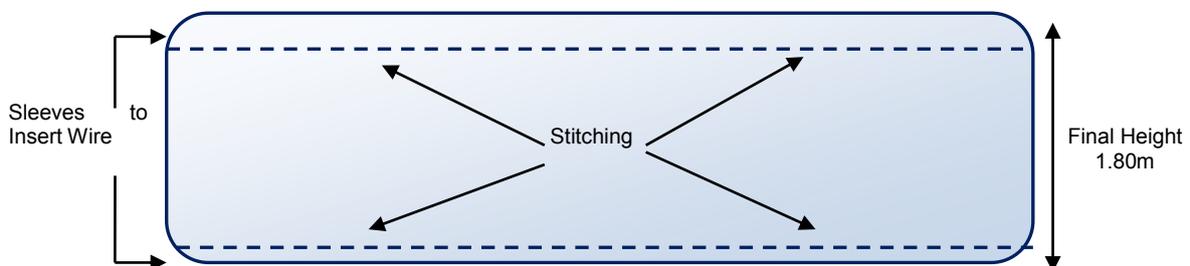
Figure 4.2 Shadecloth height and stitching details

A 100m x 1.8m shadecloth material was stitched to create a sleeve top and bottom which could carry a 2.8mm high tensile fence wire. This method of attaching the shadecloth to the wire was chosen over other methods (clips, wire ties) due to its practicality, strength, safety and most importantly the ability of stretching the shadecloth both vertically and horizontally without ripping the shadecloth. A 2.8mm high tensile with 8kN breaking strain wire was chosen as it is readily commercially available and had sufficient tensile strength to support the weight of the shadecloth material and make the shadecloth sufficiently taut to provide a solid barrier to wildlife. The high tensile wire will require a force equivalent to a static load 800kg on the wire to break it, therefore the probability of the wire breaking is reduced and debris should brush off the fence.

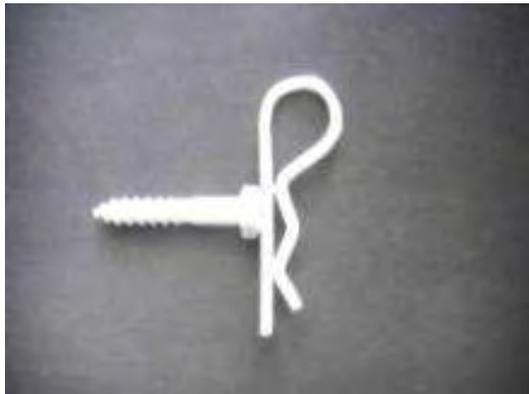
Figure 4.4 R Shear Clip Design

One of the essential criteria for the fence is that the fence is able to be removed quickly and for it to be strong enough to take the tensioning strain horizontally without detaching from posts but releasing from the post if a sudden load such as a branch strike was applied vertically to the fence (figure 4.4).

The benefit of the R shear-clip is that the horizontal forces on the wire can be contained but the fence will be released when a vertical downforce is applied (ie falling branch). Once the clip or a number of clips are released the top wire will be required to suspend the fence with tolerable sag until maintenance staff can insert the wire back into the clip.

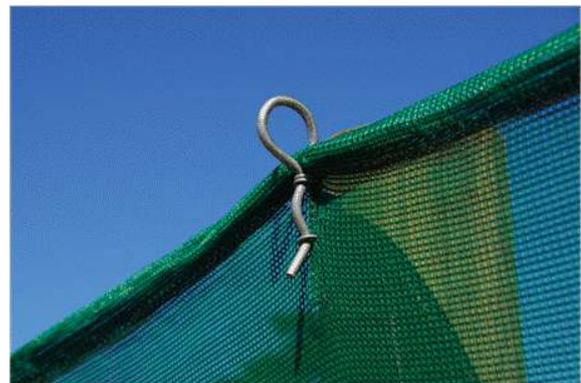
Figure 4.5 R Shear Clip installed

A shear mechanism was developed to attach the shadecloth fence (top and bottom wires) to the fence posts; this device was designed using a standard steel 75mm R-clip welded to a galvanised coach screw. (figure 4.5).

The diameter of the 2.8mm wire with the shade cloth was insufficient to be held within the R clip and some of the clips released immediately. Standard “Maspro clip” wire was used to hold the ends of the R-clips together and to create a stronger shear tension. Maspro clips were installed for the entire fence length.

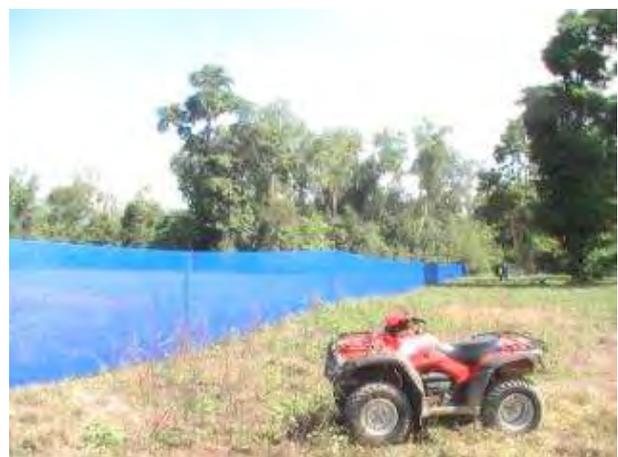
Figure 4.7 Trial #2 Sag Test

The fence was tested as a suspension fence with post spacing at 5m, 7m, and 10m spacing. With the fence erected and all available clips attached; the sag between the fence posts was minimal in all spacings. A test where up to six (6) consecutive clips were detached from the top wire resulted in a sag where lowest point reached was to a height of 1.35m (Picture 4.6). Strength and fence integrity was not compromised with the six clips detached.

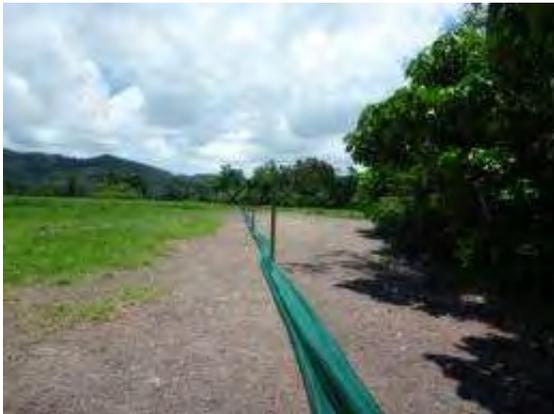
Figure 4.12 Dropped fence

The second trial was to complete the fence by clipping up the top wire and then trial dropping the fence to simulate a cyclone event. The fence was dropped down by one person by un-tensioning the turnbuckles and eyelet bolts. The shade cloth was rolled and secured to the posts by the use of a plastic cable tie.

Re-erecting the fence was more difficult and specific tensioning equipment (small hand winch or lever system) will be required to re-join the top wire to turnbuckles.

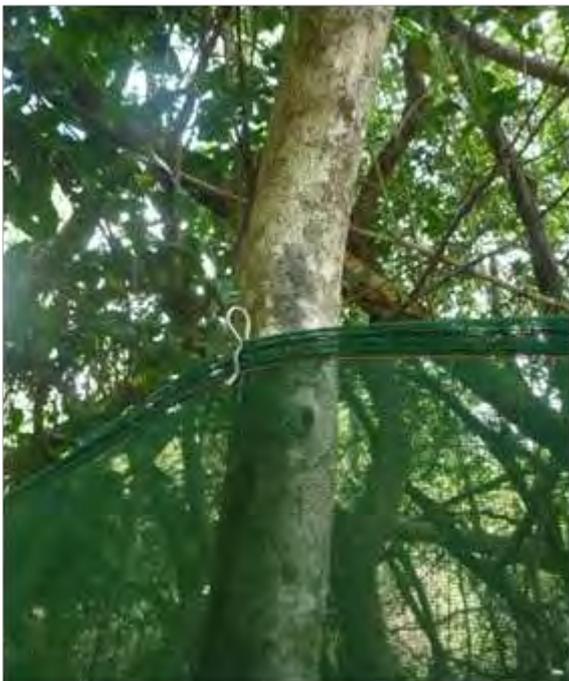
Figure 4.15 Shear clip attachment to tree using coach screw Untouched for 1½ years

Photo Fig 4.17 was taken after erection, and photos Fig 4.14, 4.15 & 4.16 were taken after 1½ years after with the only maintenance being removal of a log and re-clipping the fence shown in Figure 4.28 and 4.29.

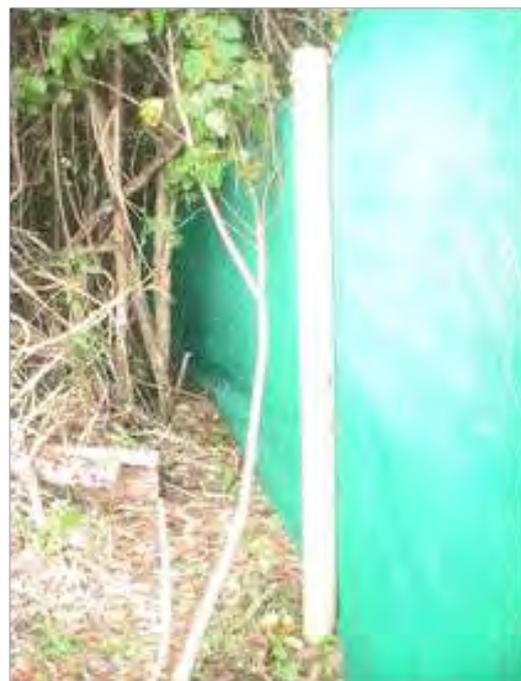
Figure 4.17 Fence within, dense vegetation showing minimal clearing

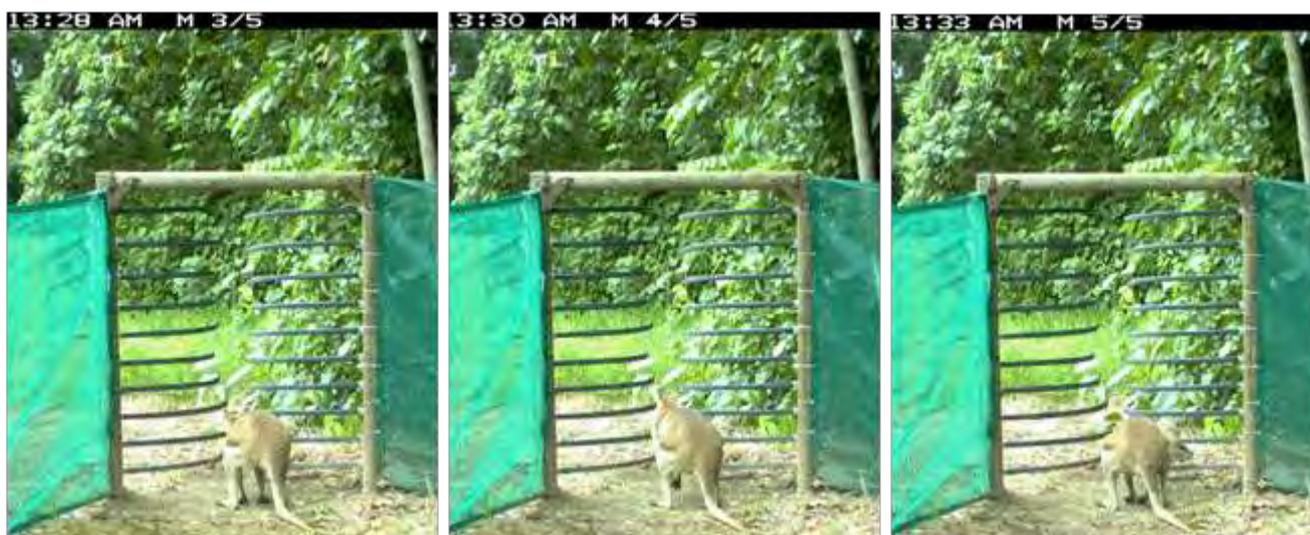
However Agile wallabies were recorded using the gate on numerous occasions. It appears that if the wallabies accessed the revegetation they then exited through the cassowary gate. there are no instances of the wallabies accessing the gate from the incorrect one way direction.

Figure 4.32 One of numerous examples of Agile wallabies using the cassowary one-way gate

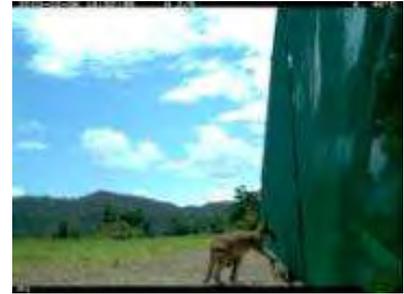
Figure 4.37 Wallaby testing fence

The extent of the repeated wallaby attack was unexpected and various efforts were trialed including gas cannon, Bitterant spray, and killing the grass for a further 20m to the fence without success. The only deterrent to be effective was a single electric wire running approximately 300mm above the ground. This instantly stopped the attacks and little further damage was caused. It is interesting that the wallabies repeatedly attacked the fence but did not venture around the ends of the fence through the vegetation or cross the creek from other clearings to reach the newly planted palms and shrubs.

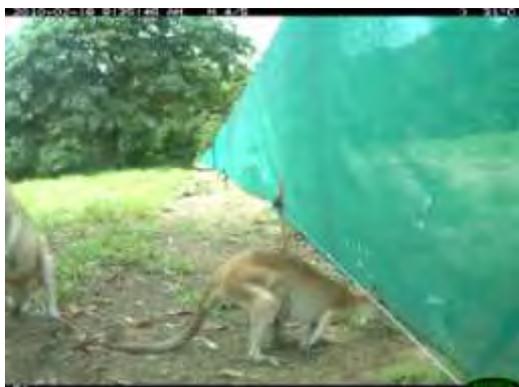
Figure 4.39 Wallaby testing the electric fence

It appears that the habituation of the displaced wallabies to that area was strong. After 12 months with an energised electric fence the fence was turned off and there were very few attempts to cut through the shadecloth.

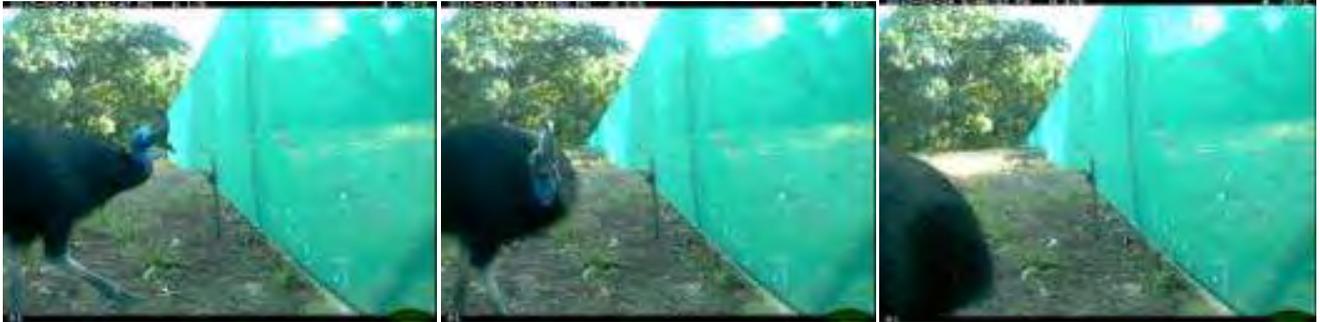
is a totally different behaviour to that reported and observed with Cyclone mesh fences where the cassowary tracks repeatedly back and forward along the fence and demonstrates the same behaviour observed with the captive cassowaries at the Johnstone River Crocodile Farm.

Figure 4.41 Cassowary interaction with the fence showing the cassowary turning and walking away. .
